**LAKE SHENANDOAH DAM  
NJ 00099**

**PHASE 1 INSPECTION REPORT  
NATIONAL DAM SAFETY PROGRAM**

March, 1979

7. AUTHOR(s) Richard J. McDermott, P.E.		6. PERFORMING ORG. REPORT NUMBER
9. PERFORMING ORGANIZATION NAME AND ADDRESS Storch Engineering 220 Ridgedale Ave. Florham Park, N.J. 07932		8. CONTRACT OR GRANT NUMBER(s) (15) DACW61-78-C-0124

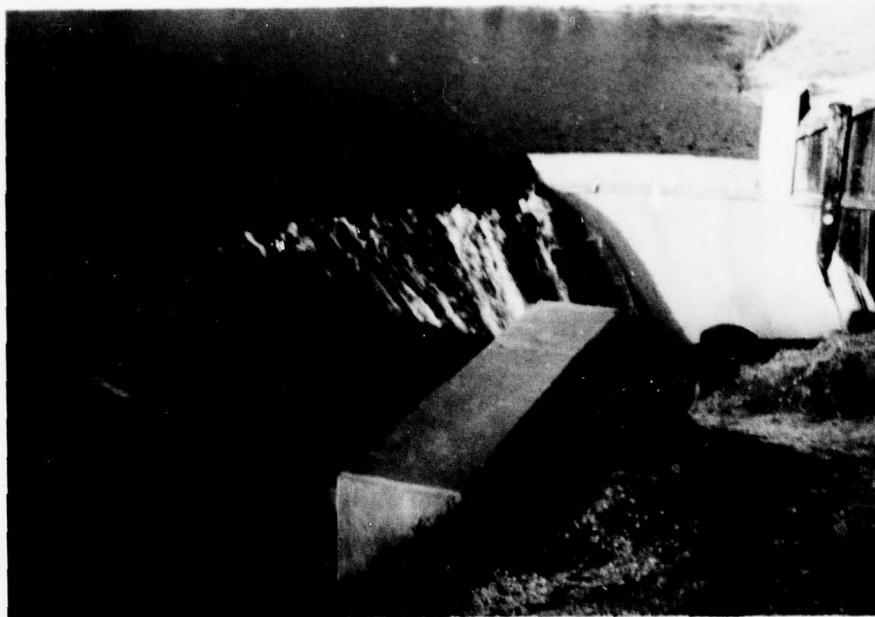
PHOTO 1  
SPILLWAY

The crest of the spillway appeared uniformly aligned, although a major part of it was submerged by overflow at the time of inspection. Water was flowing over the principal (elev. 24.4) part of the spillway and, therefore, the condition of much of the spillway surface was not clearly observed. In the sections of the spillway which were dry, some cracking and spalls, as well as leaching, were observed. In general, all concrete appeared to be in good condition.

- c. Pressure grout all major cracks and patch all spalls and eroded surfaces.
  - d. Seal the leak at the joint between the fishway inlet and the spillway.
5. The silt layer should be cleaned from the downstream end of the outlet pipe.

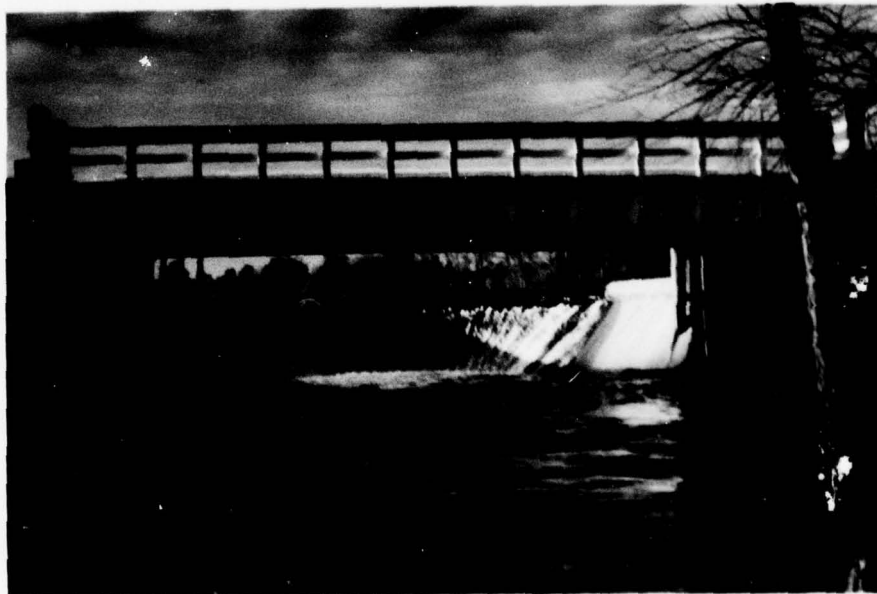
PHOTO 2  
ROAD BRIDGE OVER SPILLWAY DISCHARGE CHANNEL

The timber bridge over the spillway appeared to be in good condition.

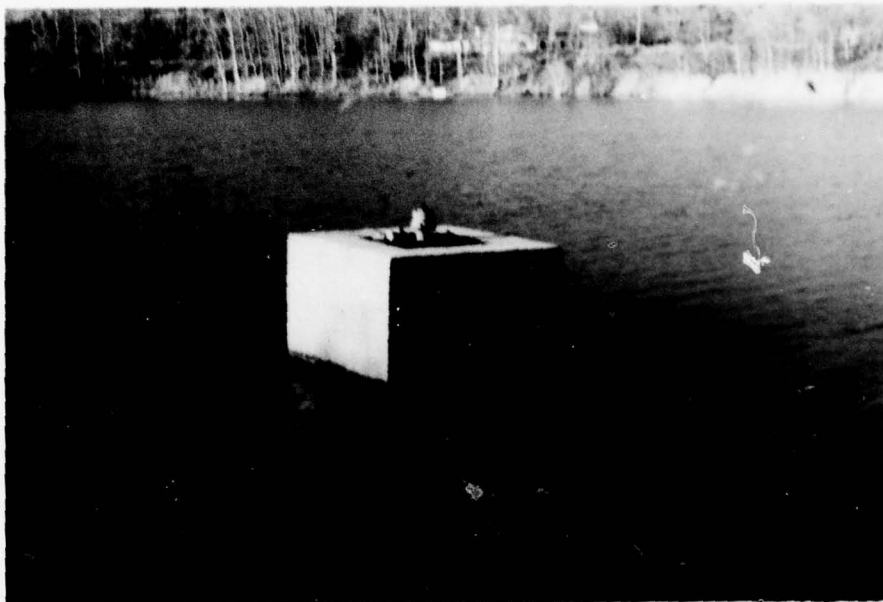
PHOTO 3  
OUTLET WORKS MANHOLE

Reportedly, the outlet equipment is in good working condition, although its operation was not observed at the time of inspection. The 48" diameter C.M. pipe was examined at its outlet end and appeared to be in good condition. However, a silt layer of 6 inches depth was observed at the invert of the pipe. The manhole housing the outlet gate was observed to be in good condition.

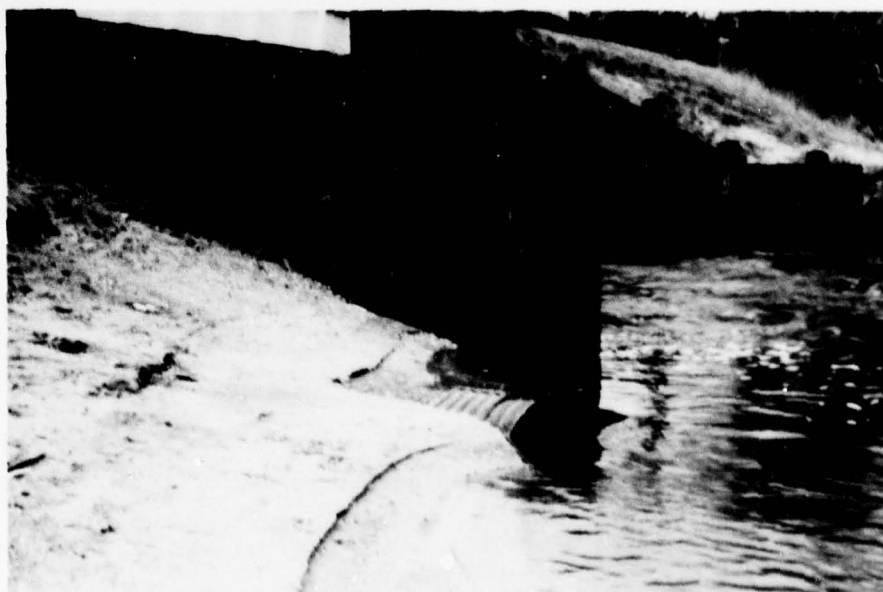
PHOTO 4  
TIMBER SHEETING FORMING SPILLWAY DISCHARGE CHANNEL  
CORRUGATED METAL OUTLET PIPE

VISUAL EXAMINATION OF	OBSERVATIONS	REMARKS OR RECOMMENDATIONS
CRACKING AND SPALLING OF CONCRETE SURFACES IN OUTLET CONDUIT	N/A	
INTAKE STRUCTURE	Gated intake in conc. box manhole approximately 35' from edge of lake.	
OUTLET STRUCTURE	48" Corrugated metal pipe. Invert 42" below stilling pool elevation. 6" silt layer on bottom of pipe.	
OUTLET CHANNEL	N/A	
EMERGENCY GATE	NONE

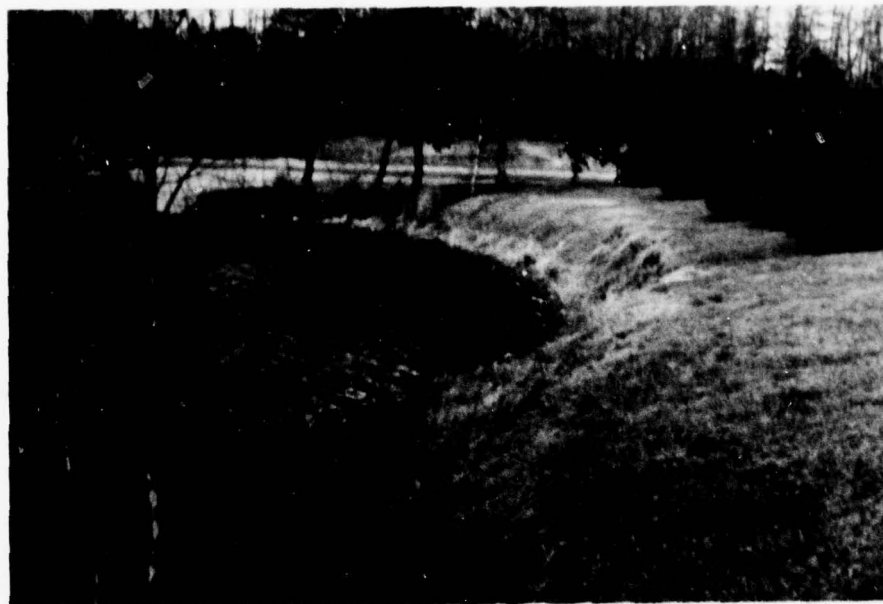
PHOTO 5  
UPSTREAM FACE OF DAM

Significant erosion was noted along most of the upstream face of the embankment and in some areas of the downstream face, especially adjacent to the spillway discharge channel. Steel sheet piling is exposed in some of the eroded areas. With the exception of the eroded areas, the grass cover on the embankment was in good condition. No riprap was found on the embankment surfaces. Considerable brush and trees were noted on the downstream face and toe of the embankment.

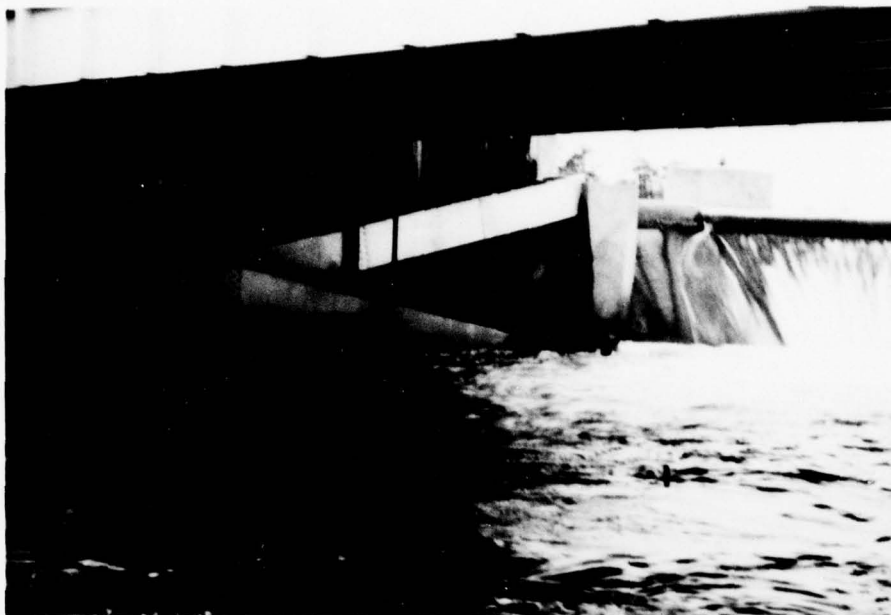
PHOTO 7  
FISHWAY

The fishway was in good condition except that slight leakage was observed at the top of the ladder where it is connected to the concrete structure on one side of the spillway.
